CARR-1297

Benjamin Baughman Farm
4742 Baughman Mill Road
Lineboro (vicinity)

Maryland Historical Trust State Historic Sites Inventory Form

MARYLAND INVENTORY OF
HISTORIC PROPERTIES

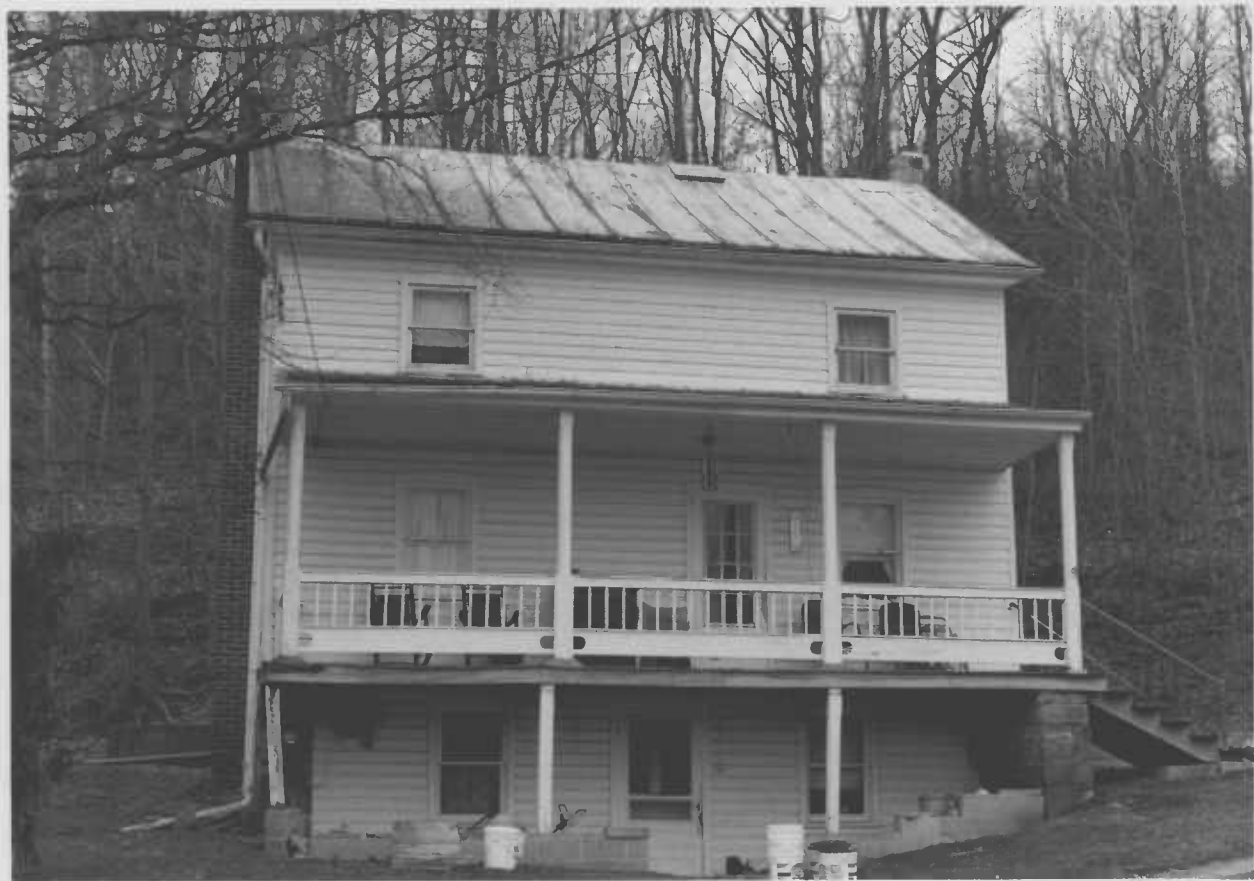
14

House - SE elev.

The house is a two-story, three-bay wide by two-bay deep banked building with a rubble stone foundation, German siding, and a standing-seam metal gable roof. It faces southeast toward the road, and the front facade has the exposed foundation wall, with a central door of two vertical lights above three horizontal panels. This is flanked on each side by a window. The first story has the same arrangement, except that the door is east of center, leaving enough space for there to have been two center doors, but there is no evidence that this ever existed. The second story has windows only in the end bays. All windows have 1/1 sash and architrave trim surrounds. There is a one-story raised porch across the front, with a shed roof of standing-seam metal, four chamfered posts, and vertical balusters that are square in section and are above a horizontal board rail. There is an external chimney centered on each end. The southwest one of brick and the northeast one of CMU's. The stairway is located in the north corner of the house.

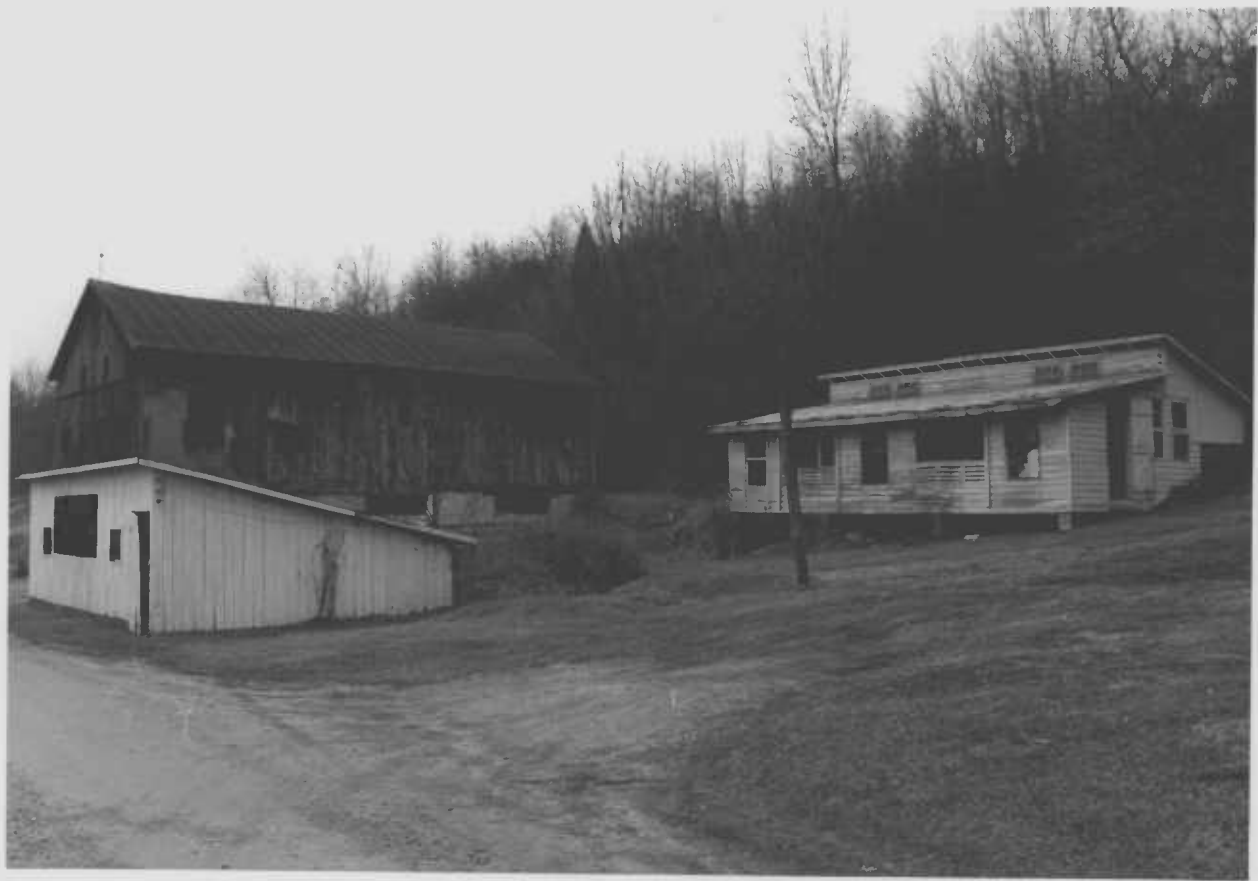
Neg. Loc.: Maryland Historical Trust
Peeling houses & barn view from east

The Benjamin Baughman Farm is located on the northwest side of Baughman Mill Road approximately ½ mile south of the Maryland-Pennsylvania line and one mile east of Lineboro. It sits at the base of a low, wooded ridge, tight against the road, in a long, linear plan. The complex consists of a clapboard house, probably of log construction, a frame bank barn, two poultry houses, a corn crib and a wagon shed.

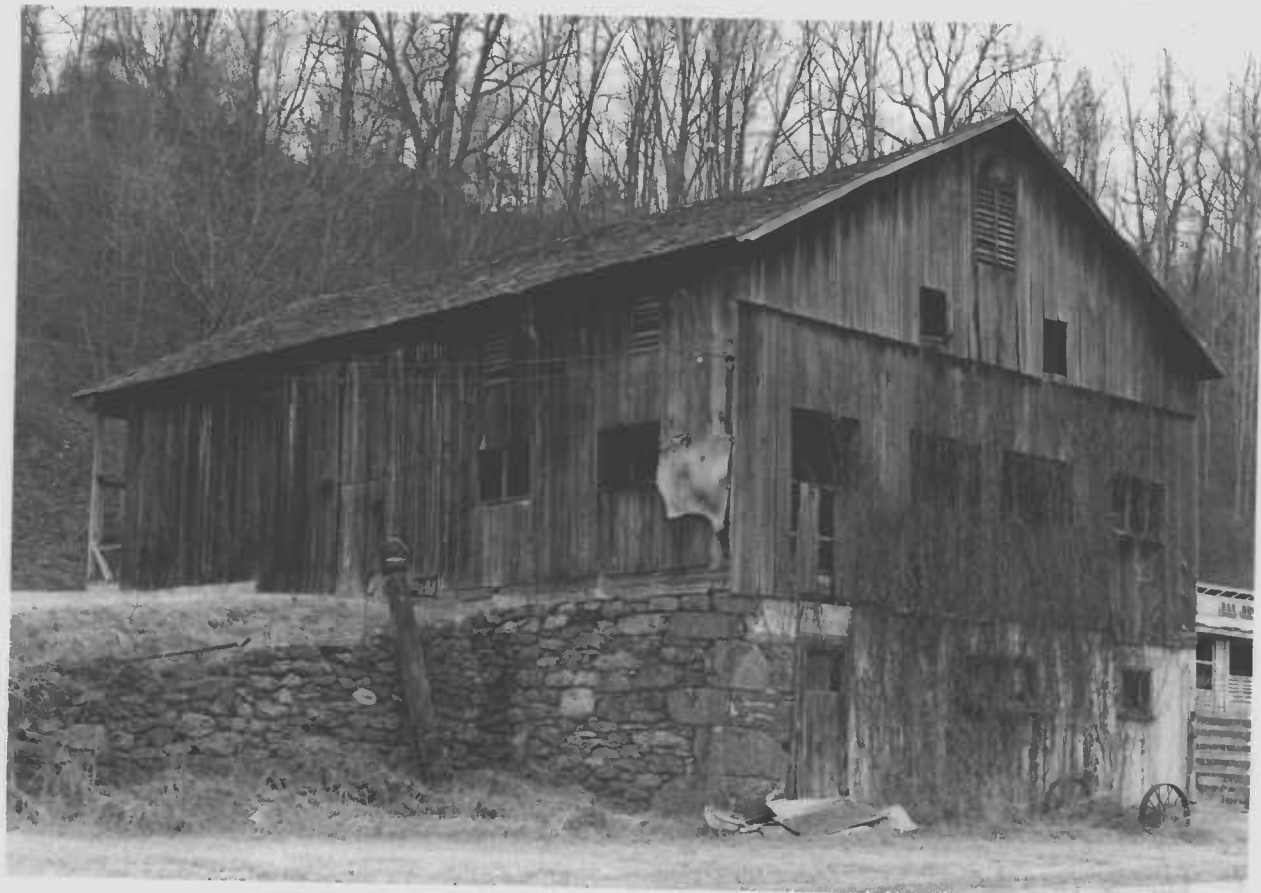
74

Barn - SW & SE elevs.

Southwest of the house is a frame bank barn turned so that the overshoot faces northeast, and both the northwest and southwest elevations are banked. The foundation is of rubble fieldstone, with a new CMU wall on the southeast and under the forebay. Part of the original lower-story wall structure here survives, but all the sheathing is gone. The lower story still retains part of its original stables, including two hay racks with the

The upper story has vertical wood siding. The upper story of the forebay is six bays, with a central pair of board doors over another pair of board doors, and two rows of five louvered wood vents. Originally, both ends had three rows of two wood-louvered vents each. The ramp end has a central pair of vertical board wagon doors on strap hinges, with a smaller inset door. The barn has a number of openings that used to be screened, when the southeast end of the upper story was converted to a poultry house. The gable roof is covered with wood shingles. The upper story is three bays, with a central threshing floor and hay mows on either end. The two end bents are markedly different than the threshing floor bents, but all four have longitudinal down braces into the hay mows. The rafters are mitered and nailed at the ridge. There is a stone wall that extends northeast from the north corner of the barn and that acts as a retaining wall for the hill as well as encloses the northwest end of the barnyard. The northeast end of the barnyard is enclosed by a fence.

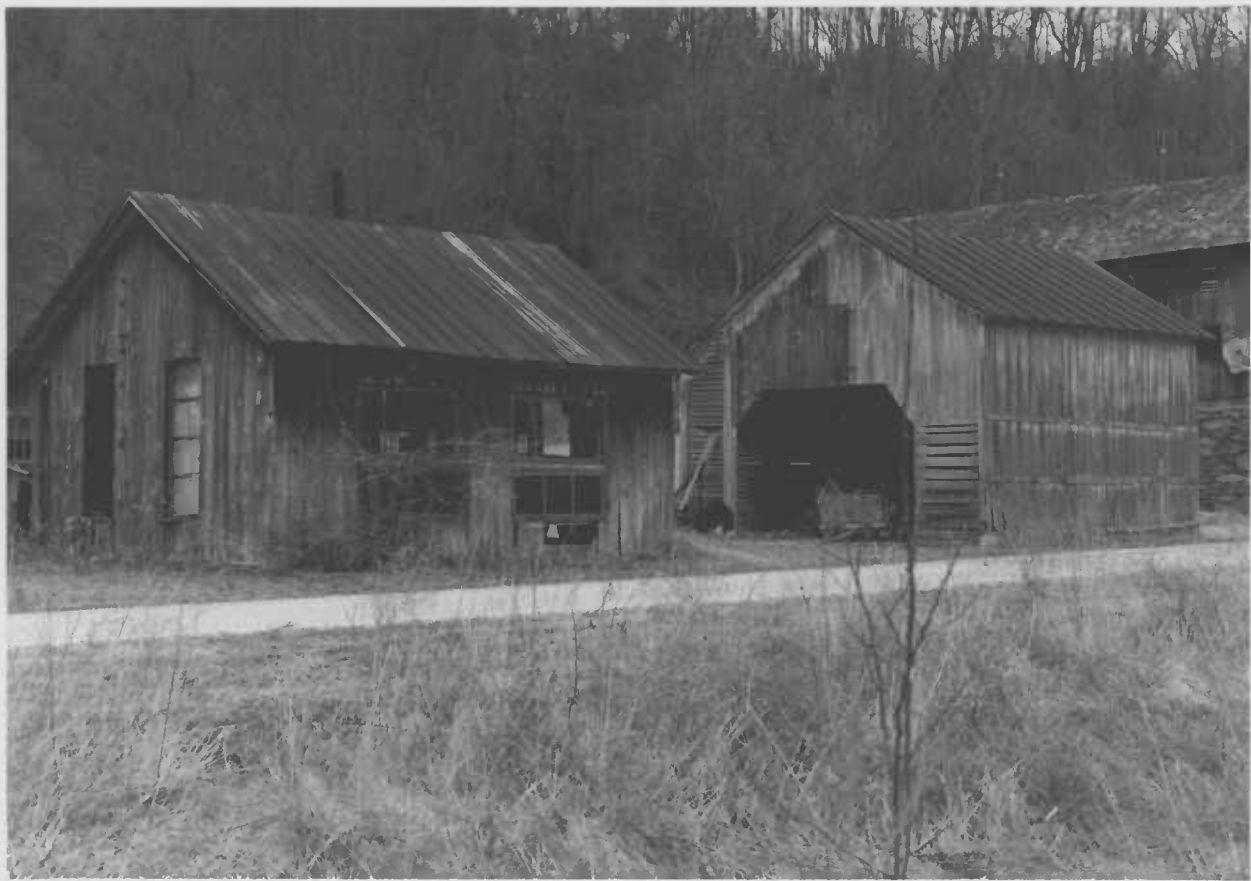
4/9

wagon shed - corn crib view from south

Southwest of the barn is a wagon shed with corn cribs on both sides, covered by horizontal slats. Both the southwest and northeast ends are open below, with vertical board siding above, a vertical board door centered in the gable end, and vertical board doors to the cribs. The gable roof is covered with corrugated metal. A one-story wagon shed is located southwest of this structure. It is constructed of sawn timbers mortised and tenoned together and covered with vertical board siding. There are double doors on strap hinges on the northeast end. On the northwest side is a shed roofed addition, which has a fixed six-light sash on both the southwest and northeast ends. The gable roof is covered with inverted "V" seam metal. The wagon shed has several later openings on the side and end that date from when it was converted to a chicken house.
